MISCELLANEOUS PAPER CERC-87-20

SIDE-SCAN SONAR INVESTIGATION OF BREAKWATERS AT CALUMET AND BURNS HARBORS ON SOUTHERN LAKE MICHIGAN

December 1987

Prepared for US Army Engineer District, Chicago
219 South Dearborn Street
Chicago, Illinois 60604-1797

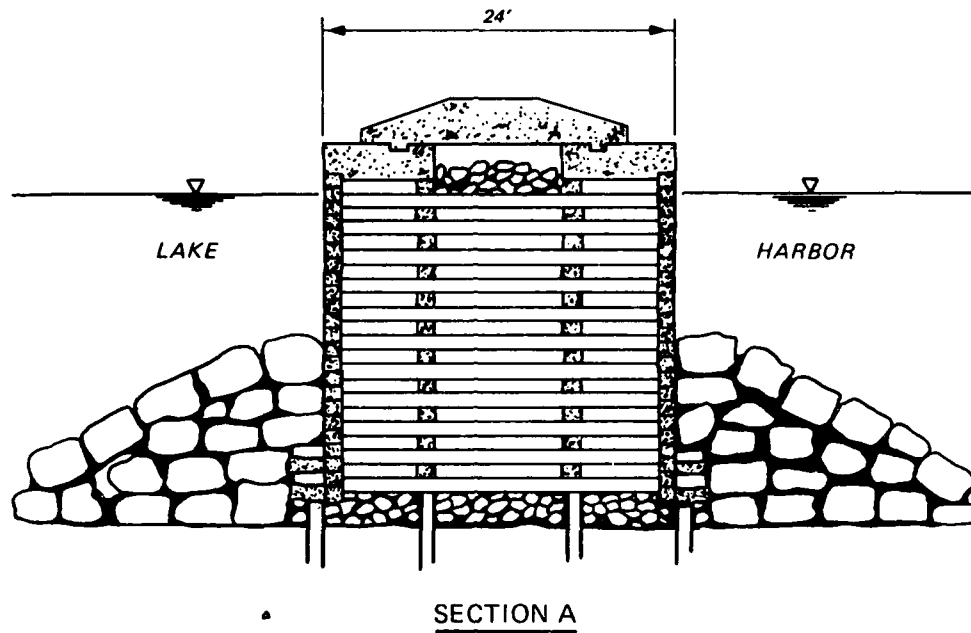
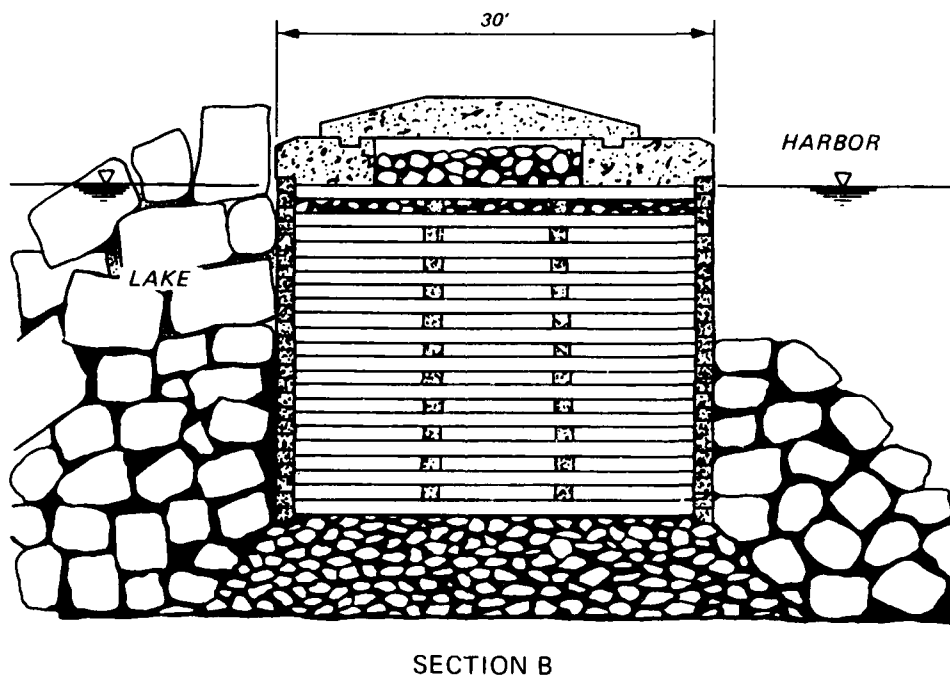
Figure 4. Wooden cribs forming Sections A and B of the Calumet Harbor attached breakwater

7. Sections A, B, and C of the Calumet Harbor breakwater were surveyed on 24 September (Figure 3) at horizontal range scales of 25 and 50 m. Sections A and B consist of wooden cribs (Figure 4) which were built on land by skilled carpenters, floated into place, and filled with stone rubble. This breakwater was completed in 1904, a concrete cap was added in the 1920's, and toe armor was added at various times.
